Subject: CR Kendall Post-Closure Environmental Impact Statement  
Effects of Historic and Modern Mining on Sediments and Water Quality  
in the Off-Site Mine Area Drainages

# CR Kendall Post-Closure EIS

## **Effects of Historic and Modern Mining on Sediment and Water Quality in the Off-Site Mine Area Drainages**

February 10, 2004

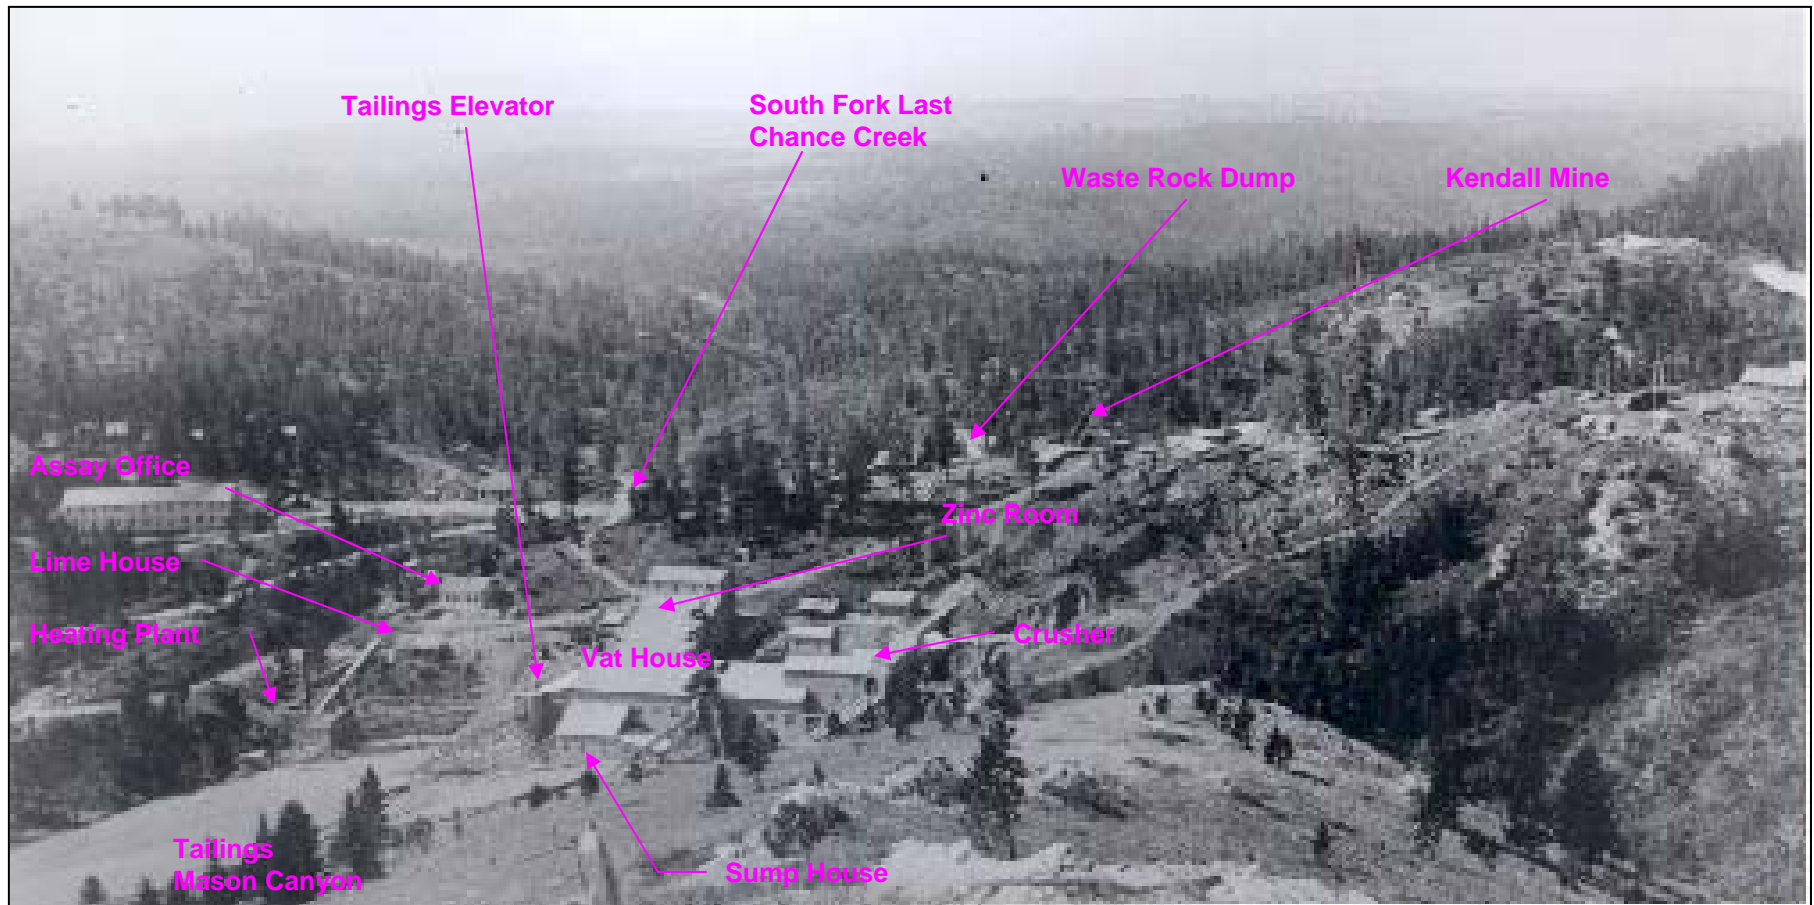
The 12 vat leaching house of the new mill was located on a very steep hillside (Sanborn, 1902, 1905, and 1908 Figures 3-1 through 3-3), presumably to facilitate more efficient removal of the tailings from the vicinity of the mill site. In later years, tailings were discharged from the vat house by use of a tailings elevator due to the height of the growing tailings pile (see Figure 3-4).

Figure 3-4  
View of the Kendall Mill and Mine Looking Southwest (Circa. 1909). Note the Tailings in the Left Foreground and the Waste Rock in the Center Background. (Photo by G.C. Morton, Courtesy of Montana Historical Society)
